SUBJECT Port Installations and Naval Vessels Observed at Poti DATE DISTR. 22 March 1957 (S)

A two-page report, with an attached sketch, describing the port installations and naval vessels observed in the port of Poti

P O T I.

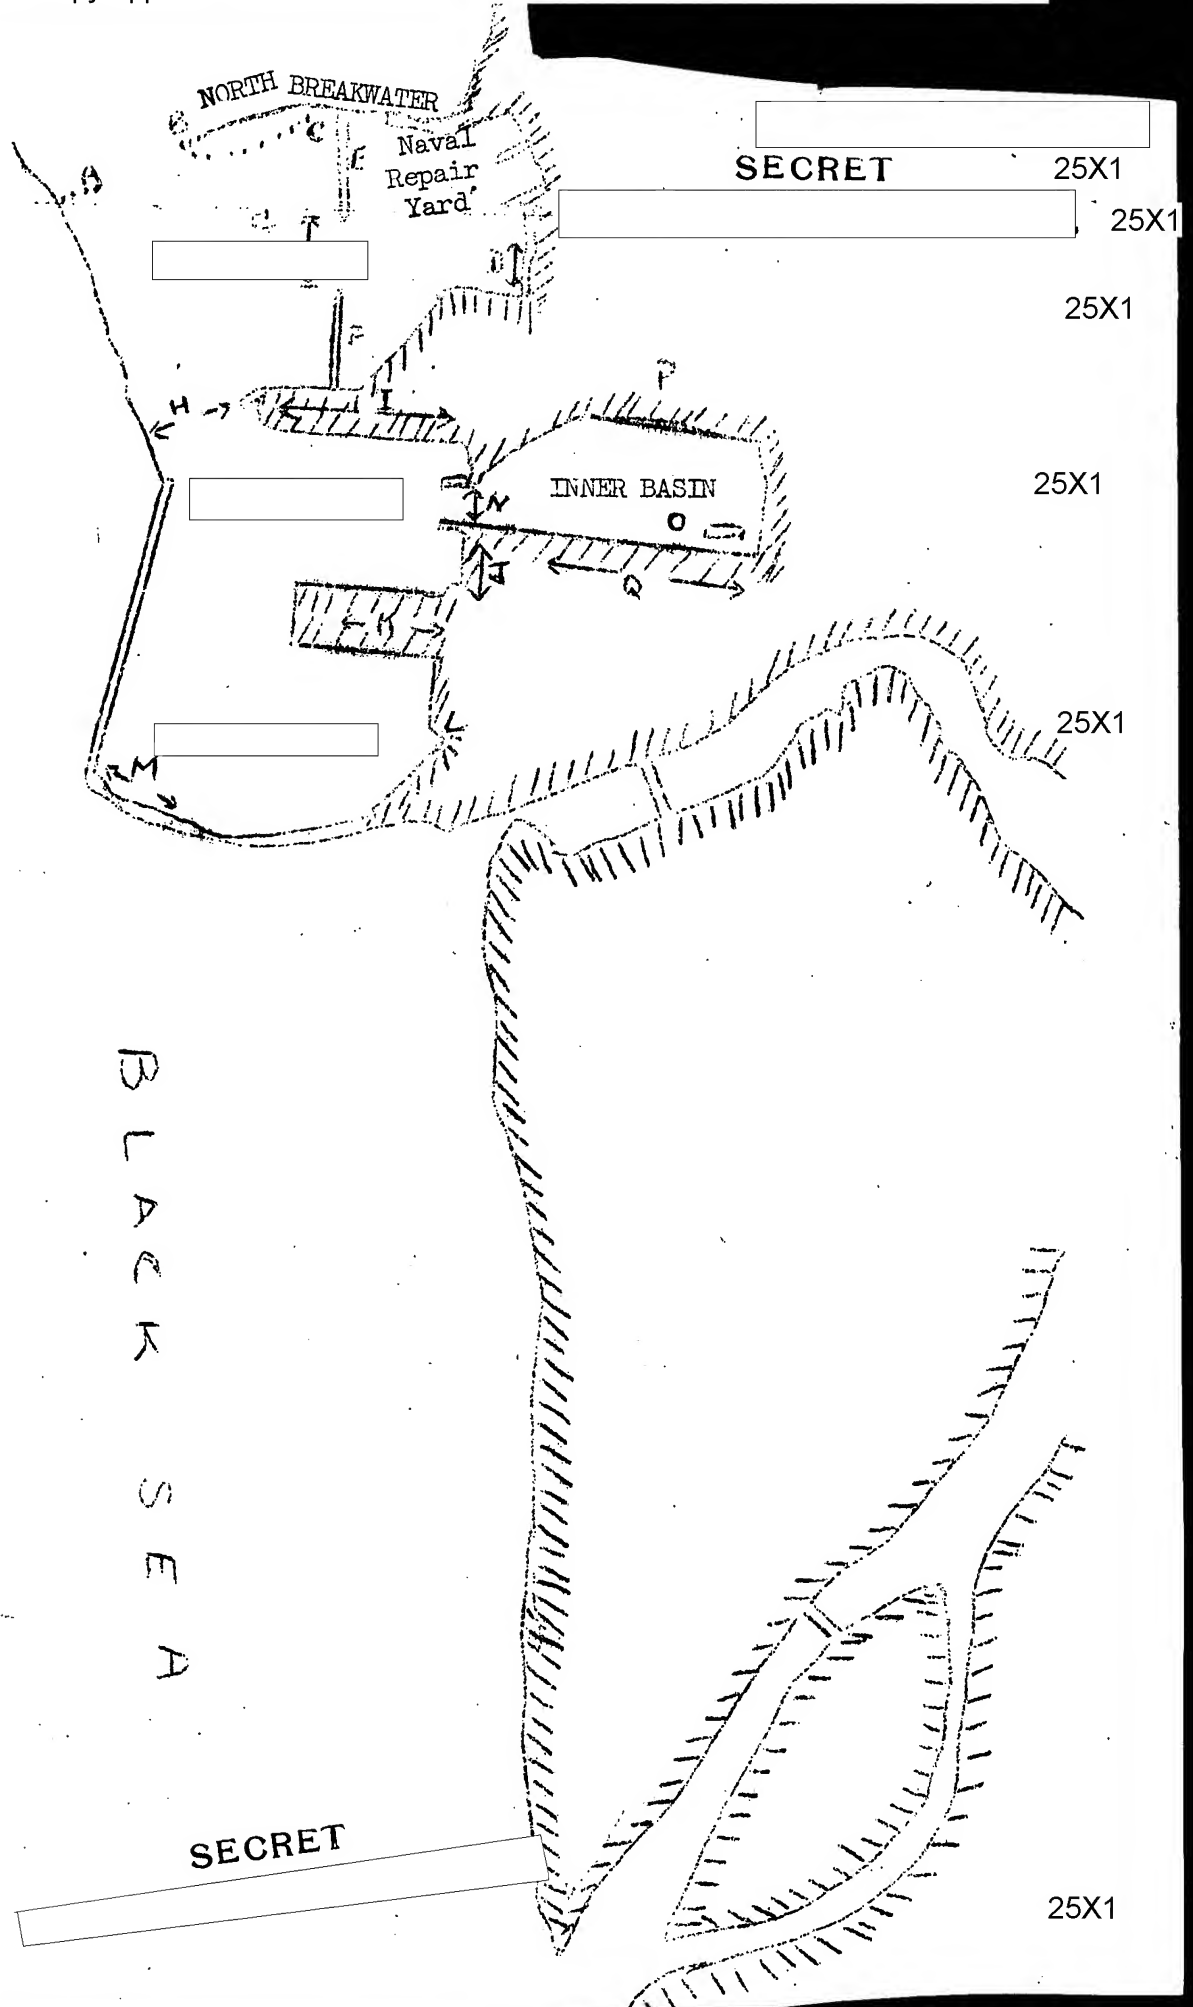
1. Two buoys have been placed in the [] entrance at points A and B (see sketch). Nets have been strung between these buoys and the adjacent breakwaters. []

[] In addition a buoyed net has been attached to buoy B which can be used to close the entrance A - B. This net is normally secured in the open position to point C on the northern breakwater.

2. An unspecified number of destroyers and 'other Naval units' were secured stern to the wall in the area D. [] the destroyers [] varied between 1,000 and 1,500 tons. 25X1

4. The sheet piling which forms the new moles E and F is being filled with concrete.

5. The entrance G to the Naval Basin is [] wide. 25X1 Destroyers were seen passing stern first through this entrance.

6. The entrance H to the North Harbour is being dredged.

7. There were approximately 7 cranes along the quay I and their load capacities were estimated to vary from 5 to 15 tons each. They were of the type that normally handle coal and were seen to unload a 4,000 ton Russian [] in under 12 hours. [] 25X1

10. A silo with an estimated capacity of 20,000 tons is located at point L. The adjacent quay can only accommodate two ships at a time.

11. The portion of the southern mole marked M is reserved for fishing boats and small craft.

12. The entrance to the Inner Basin (N) is [redacted] wide.

13. The floating dock (estimated handling capacity 5,500 tons) moored at point O was empty.

14. Mineral ore was stacked along the quay P. 10 cranes with lifting capacities varying from 15 - 20 tons were unloading ore from a 7,000 cargo ship moored alongside.

[redacted] were ranged along quay Q. The goods stored inside could not be seen, but a varied selection of metal goods and cast iron ware was stacked between the warehouses and the Basin. The quay was served by six cranes each capable of handling loads of between 10 and 15 tons.
